Site 37: Ogden Reservoir, Barley

Site Assessment

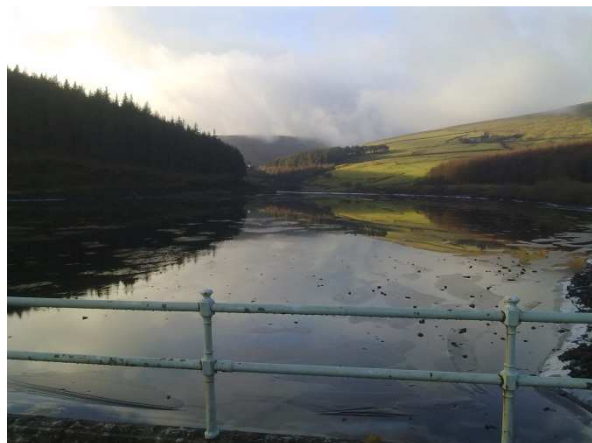
Figure 2 Lower Ogden reservoir

This site has good head potential, and is at the overflow to a large reservoir. There was unfortunately no water flowing out of the dam on the day of the site visit, and United Utilities have stated that there are no requirements at this reservoir for a compensation flow. Ogden Reservoir only overflows during flood events when the reservoir is overtopping. It is not deemed feasible to attempt to harness the water during these events as they are too infrequent. Dirty water is turned away from the reservoir via the by-wash on occasion but this is also too infrequent to be harnessed, and the flows are not measured making any potential impossible to assess. There is a piped flow to the nearby waste water treatment works of up to $0.14\text{m}^3/\text{s}$, but it is assumed that this flow is not suitable as the head is likely to be required for the water transport.

Unfortunately, due to the extent of artificial influence, the catchment for this site could not be defined and flows could not be predicted. It is unlikely that there is sufficient consistent water to supply a hydro scheme surplus to the fish pass and compensation flow requirements.

It is not recommended that any further investigation is carried out.

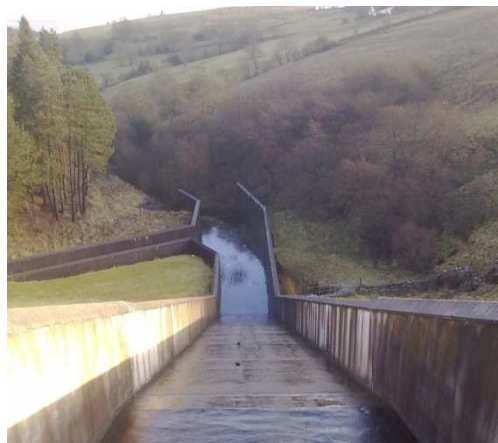
Figure3 The dry overflow
