Appendix 2 - Photographs of work in progress and following completion

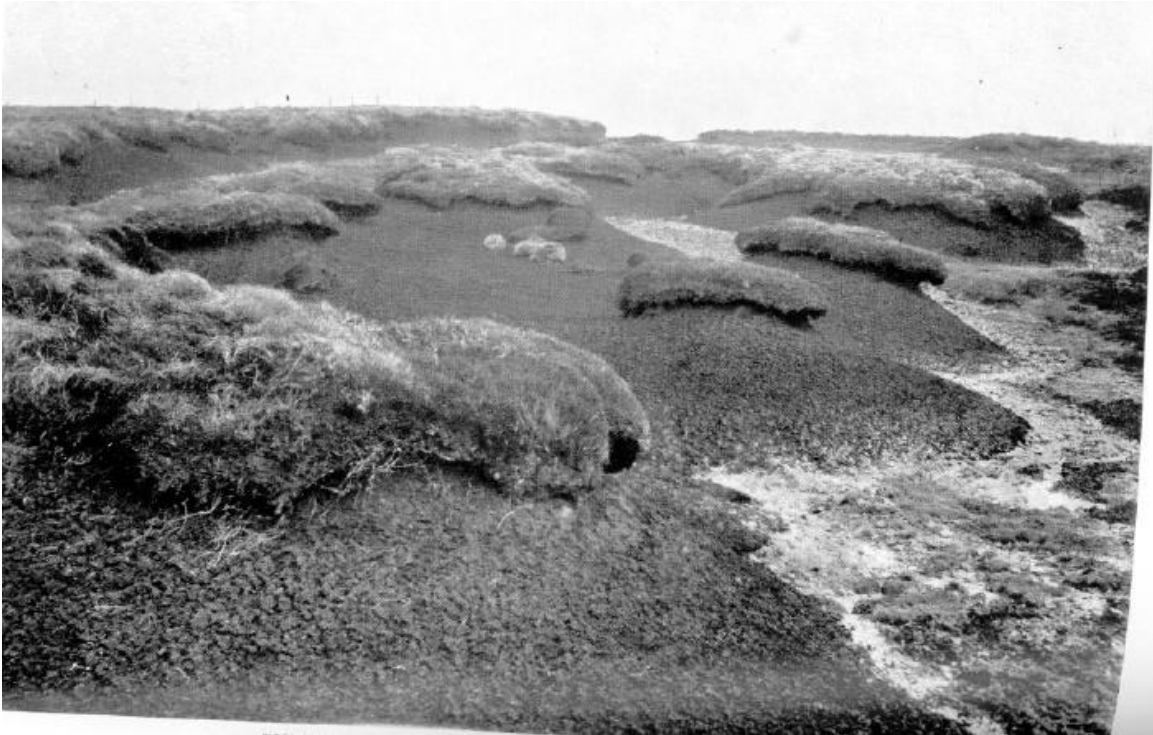
Hags and bare peat on Fairsnape, 1907

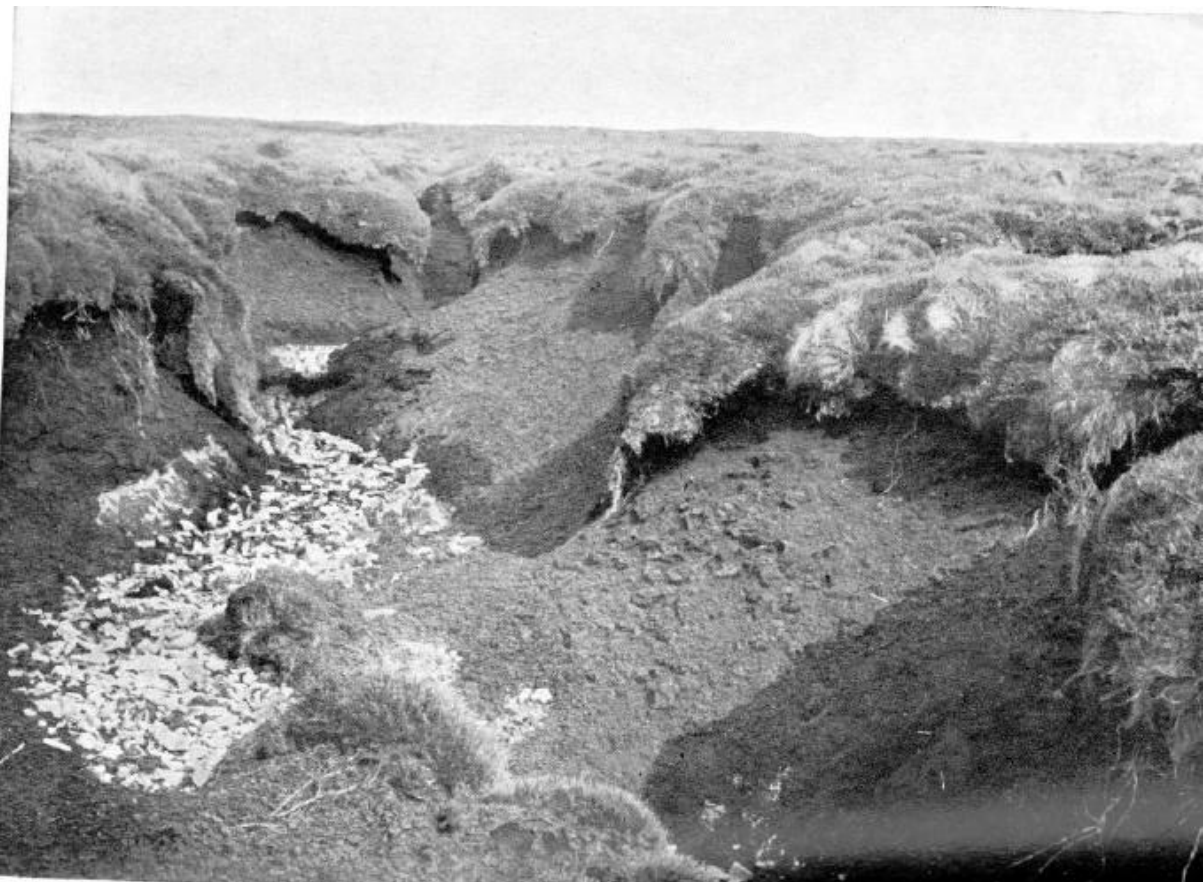
Deep gullies and drip edges on Fairsnape summit, 1907

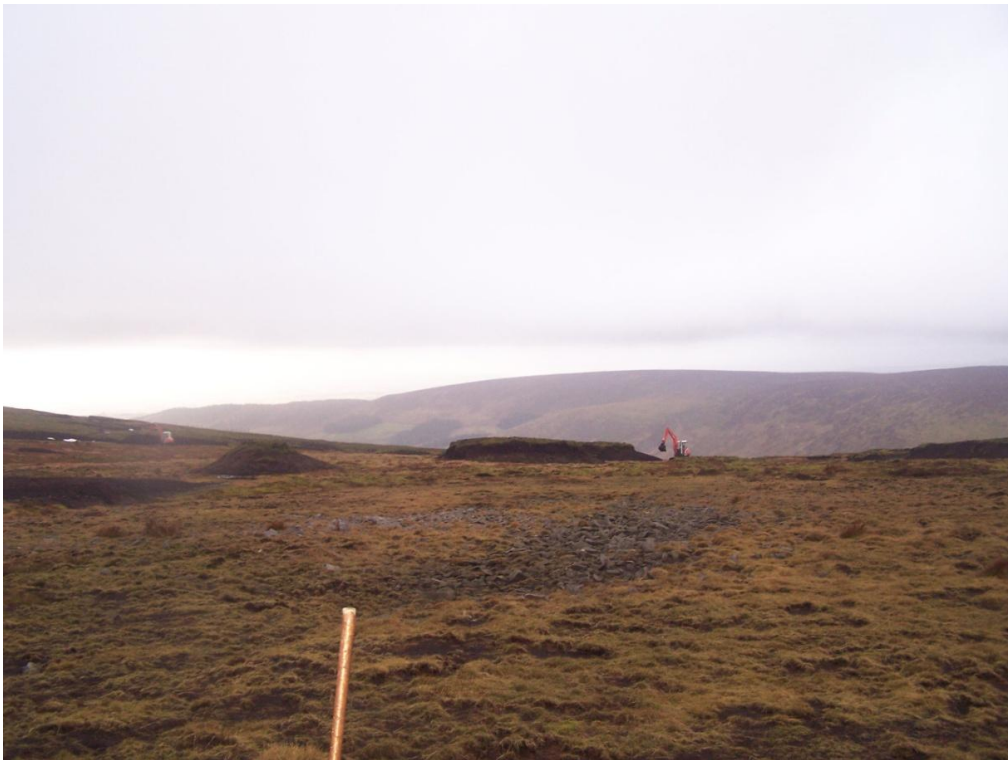
Machine reprofiling at Fairsnape, 1 Feb 2013

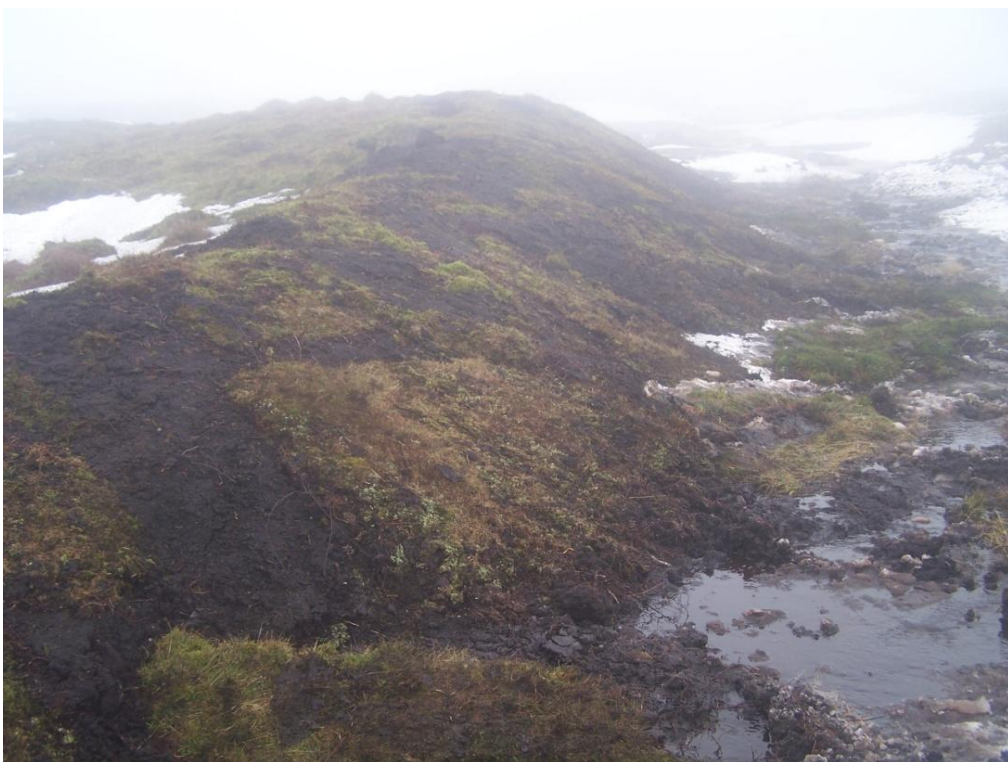
Fairsnape, re-profiled and re-turfed hag, 14 Feb, 2013

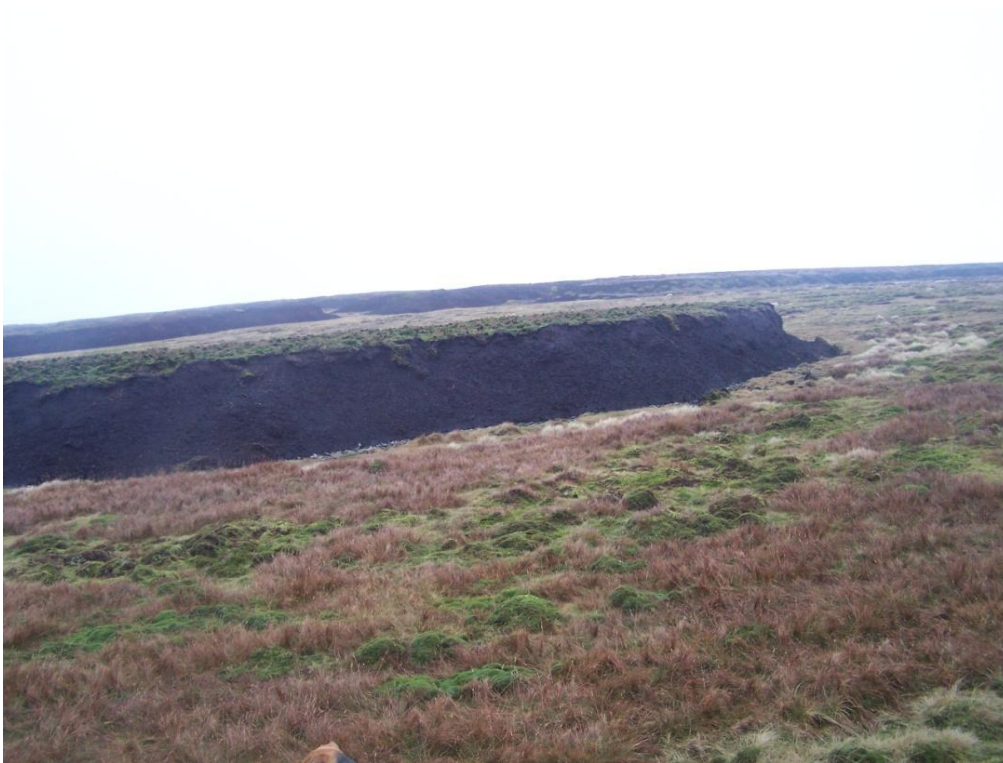
Hags at Holme House Fell, still in need of re-profiling, 1 Feb 2013

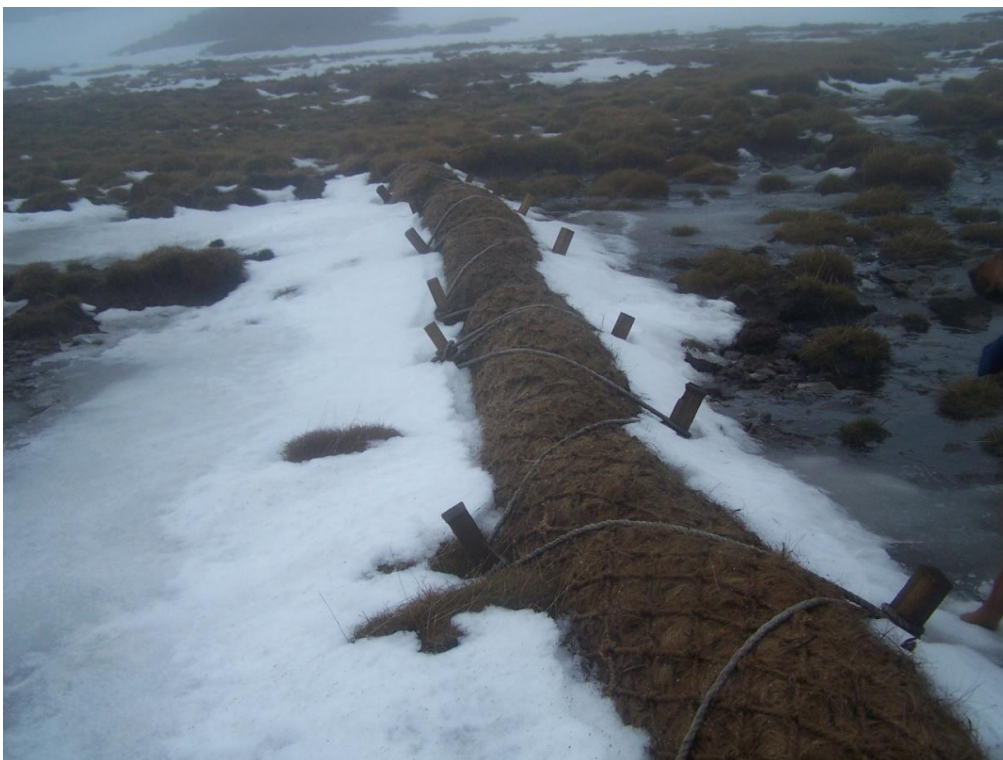
Example of coir log in situ on mineral soil at Holme House(from 2012 work), 14 Feb 2013

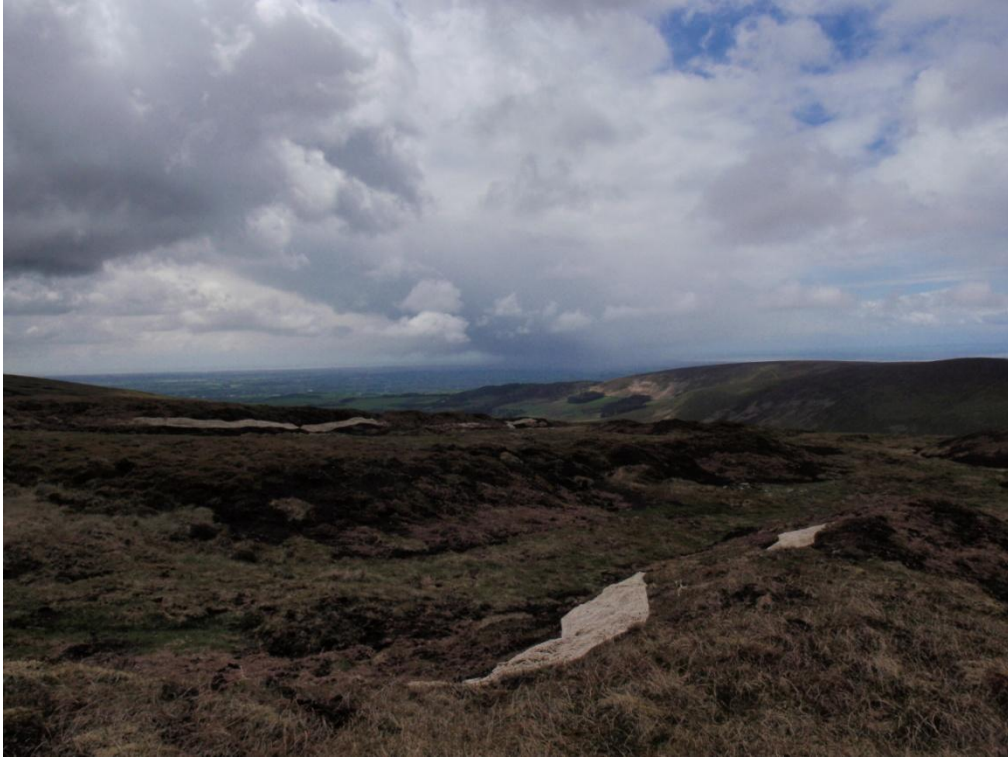
Holme House Fell re-profiled hags with geo-jute and heather brash, May 2013

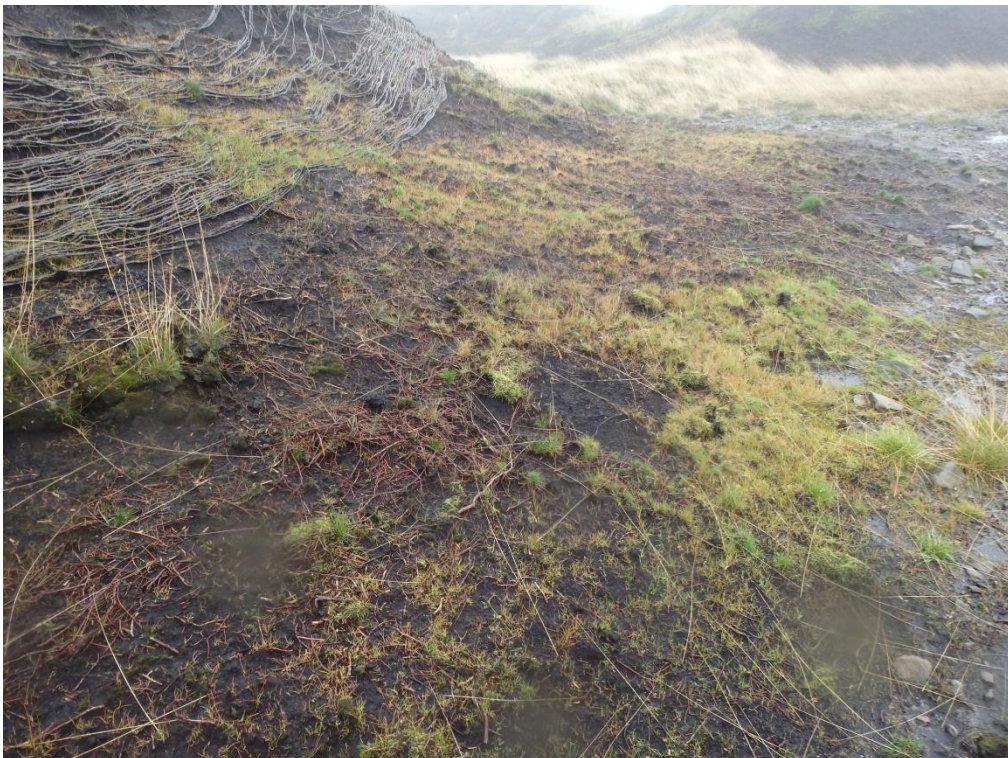
Holme House Fell showing nurse crop germination in need of further lime and seed, September 2013

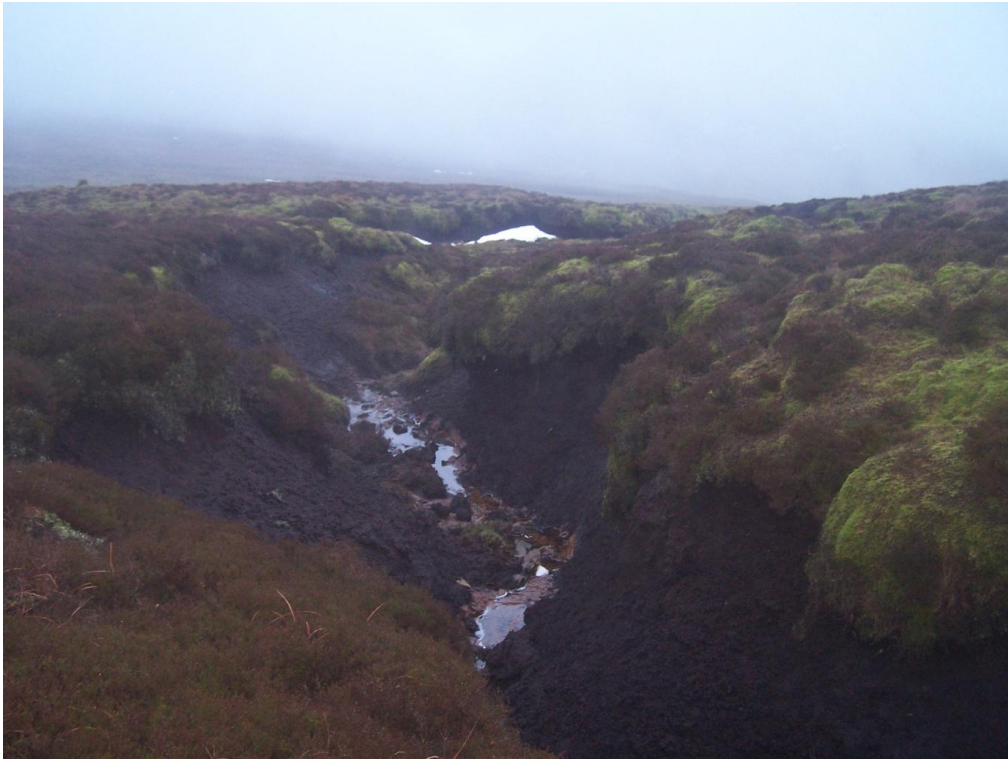
Gully at Fiendsdale Head to be re-profiled, 1 Feb 2013

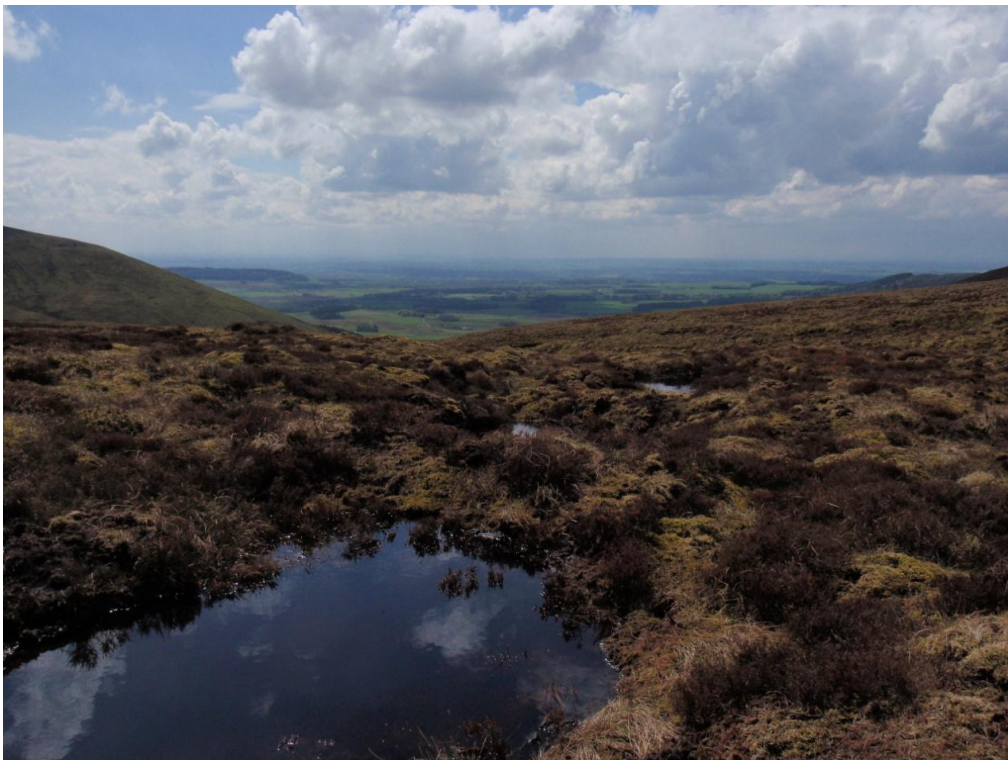
Gully at Fiendsdale Head re-profiled with check dams in place, May 2013
